Manhole Inspection Summary

Manhole # S19GG_020MH

Insp Date: **6/13/07 1:23 PM**

Location Address: **1542 APPLETON-PAYSON**

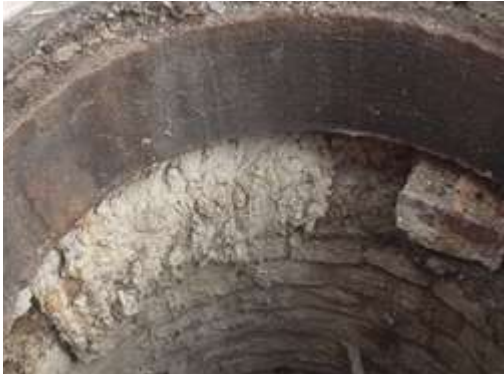
Defect 1

Condition: ☐ Sound ☐ Cracked ☐ Root Intrusion ☐ Loose Brick ☒ **Deteriorated**

DETERIORATION OF CHIMNEY

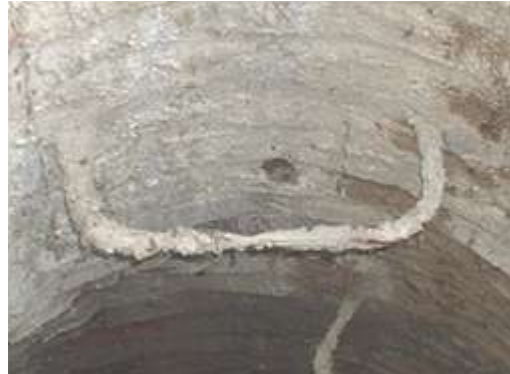
Defect 2

Condition: ☐ Sound ☐ Cracked ☐ Root Intrusion ☐ Loose Brick ☒ **Deteriorated**

SMALL HOLE IN CORBEL

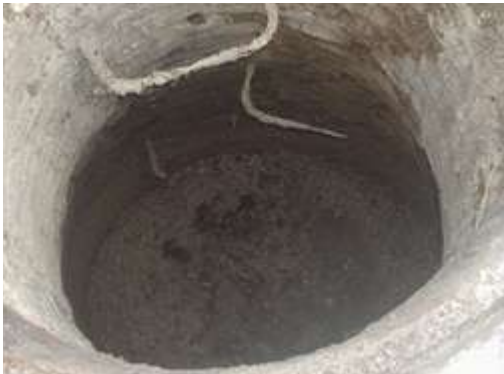
Defect 3

Infiltration: ☐ None ☐ Joint ☐ Cracks ☐ Mortar ☐ Roots ☒ **Wall**

Steps Count: **1** Missing: **1** ☒ **Corroded**

CORRODED AND MISSING STEPS,
BARREL INFILTRATION

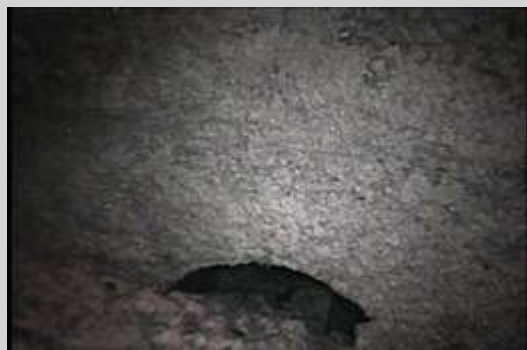
12 O'Clock Outflow

Deposits: ☐ None ☒ **Mud** ☐ Sludge ☐ Debris ☐ Grease

Silt Depth: **6** (in.) Deposits Extent: **Heavy**
